# *The Ronkonkoma HUB Study Area*

Hamlet of Ronkonkoma  
Town of Brookhaven  
New York

**September 2012**

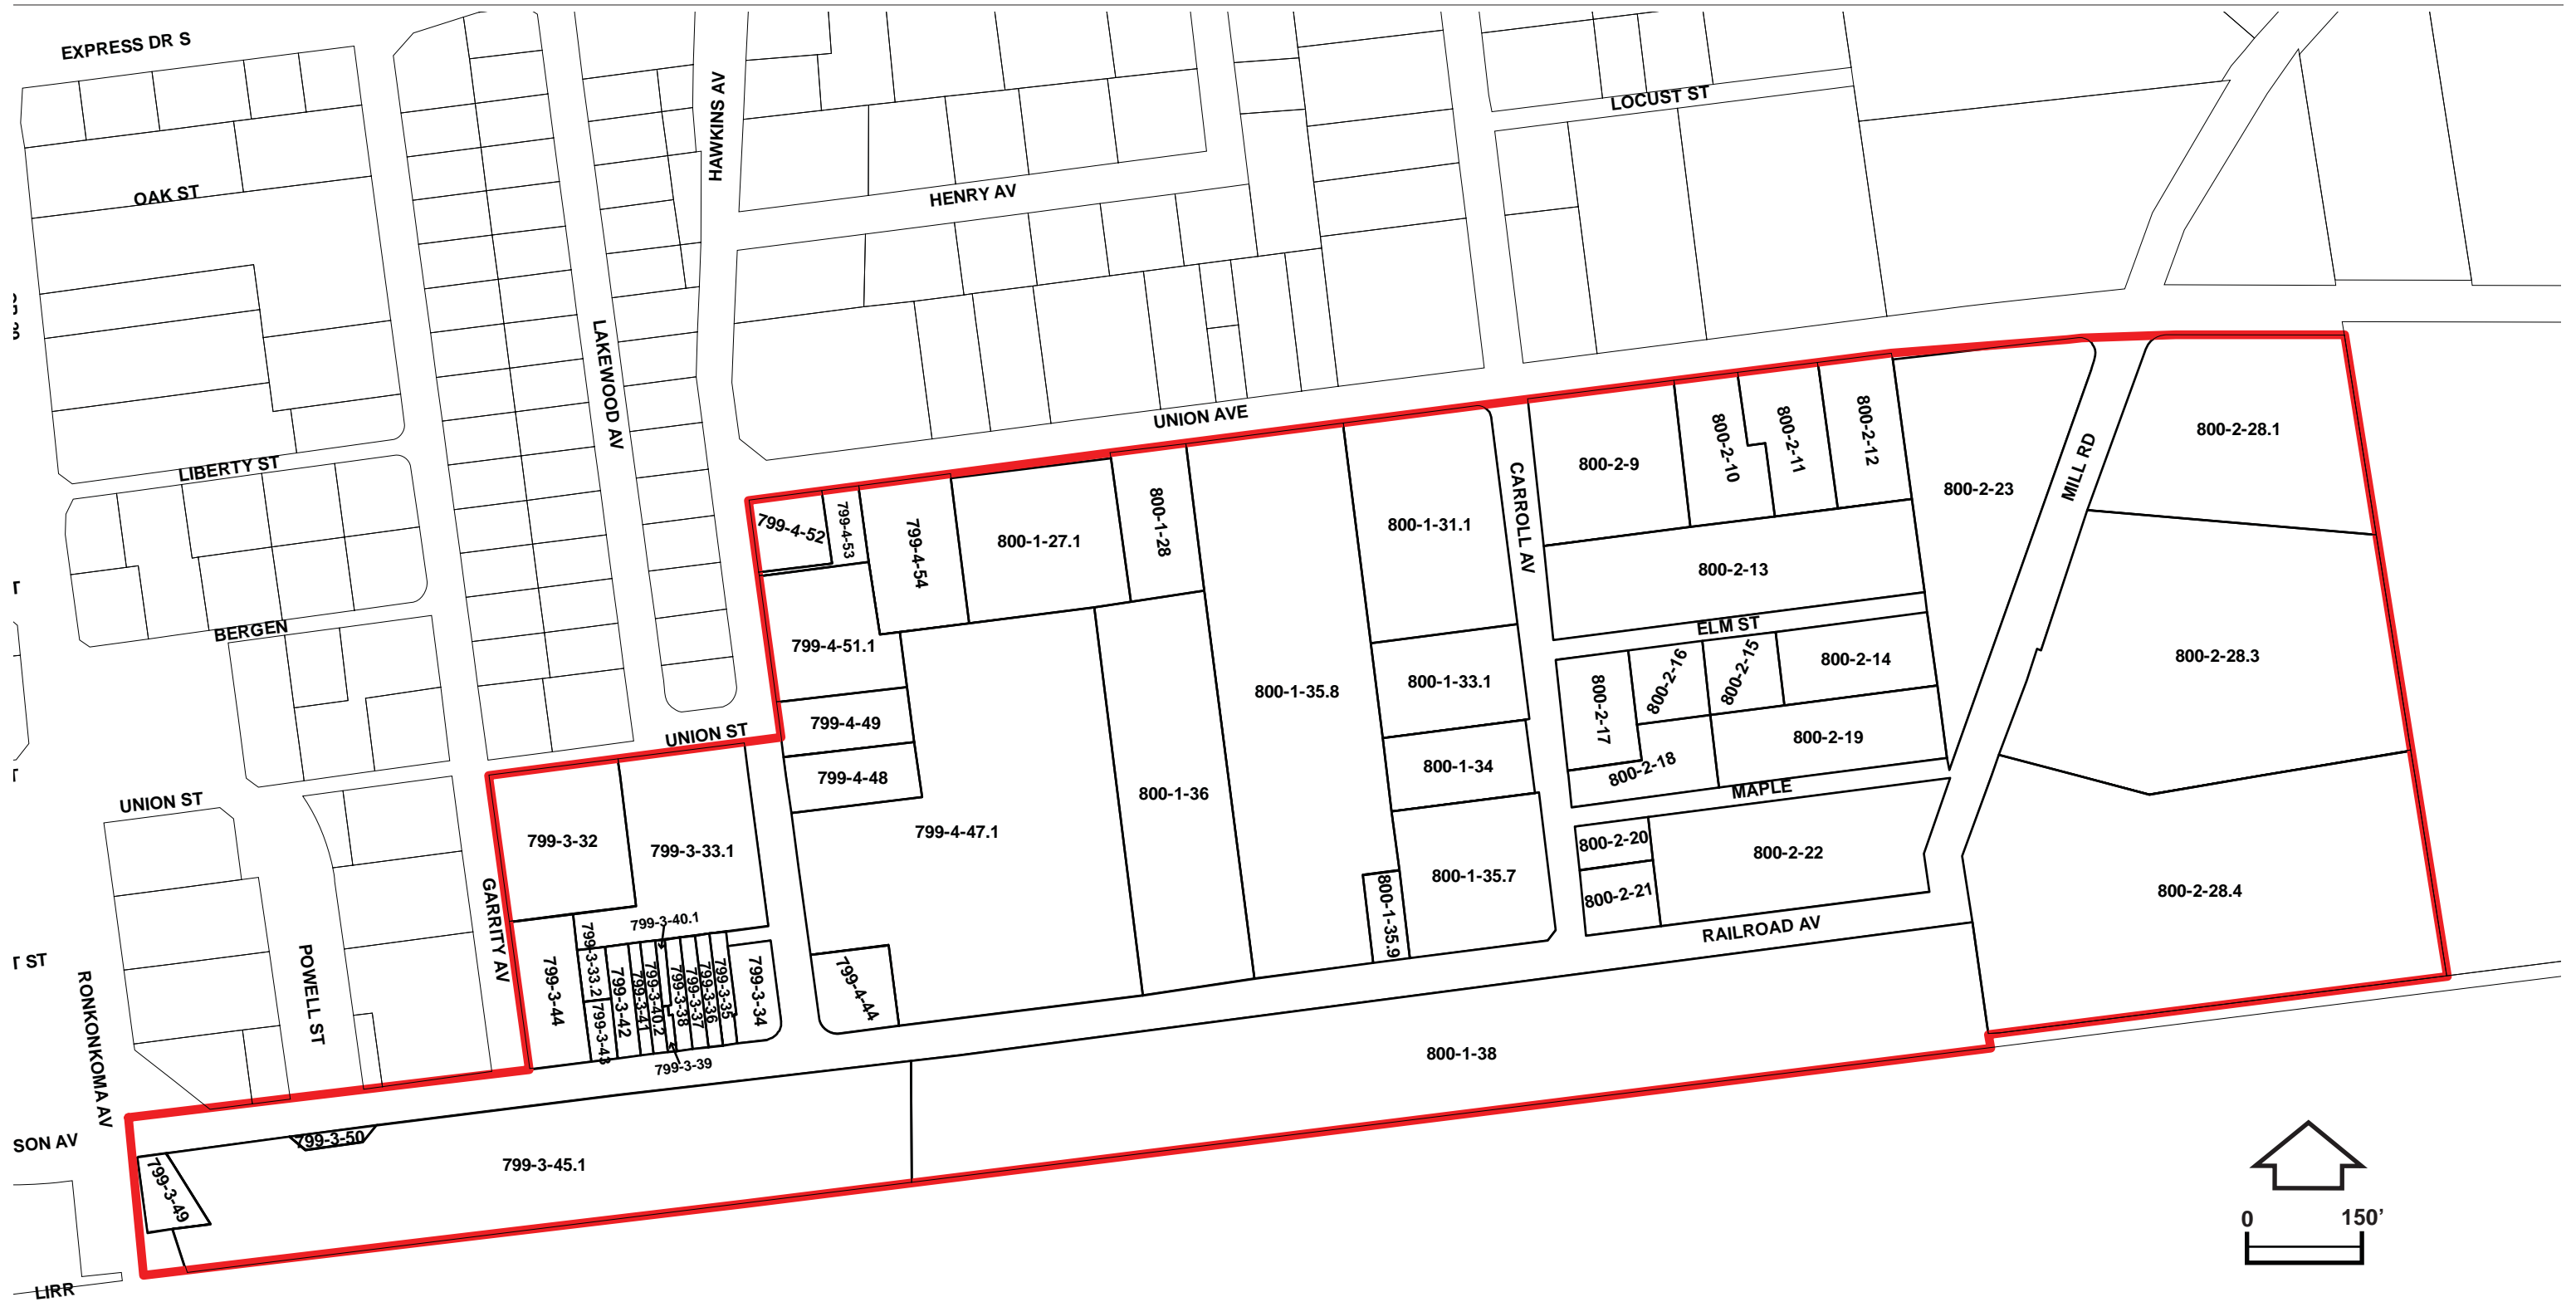
FIGURE  
2

Study Area Tax Parcels

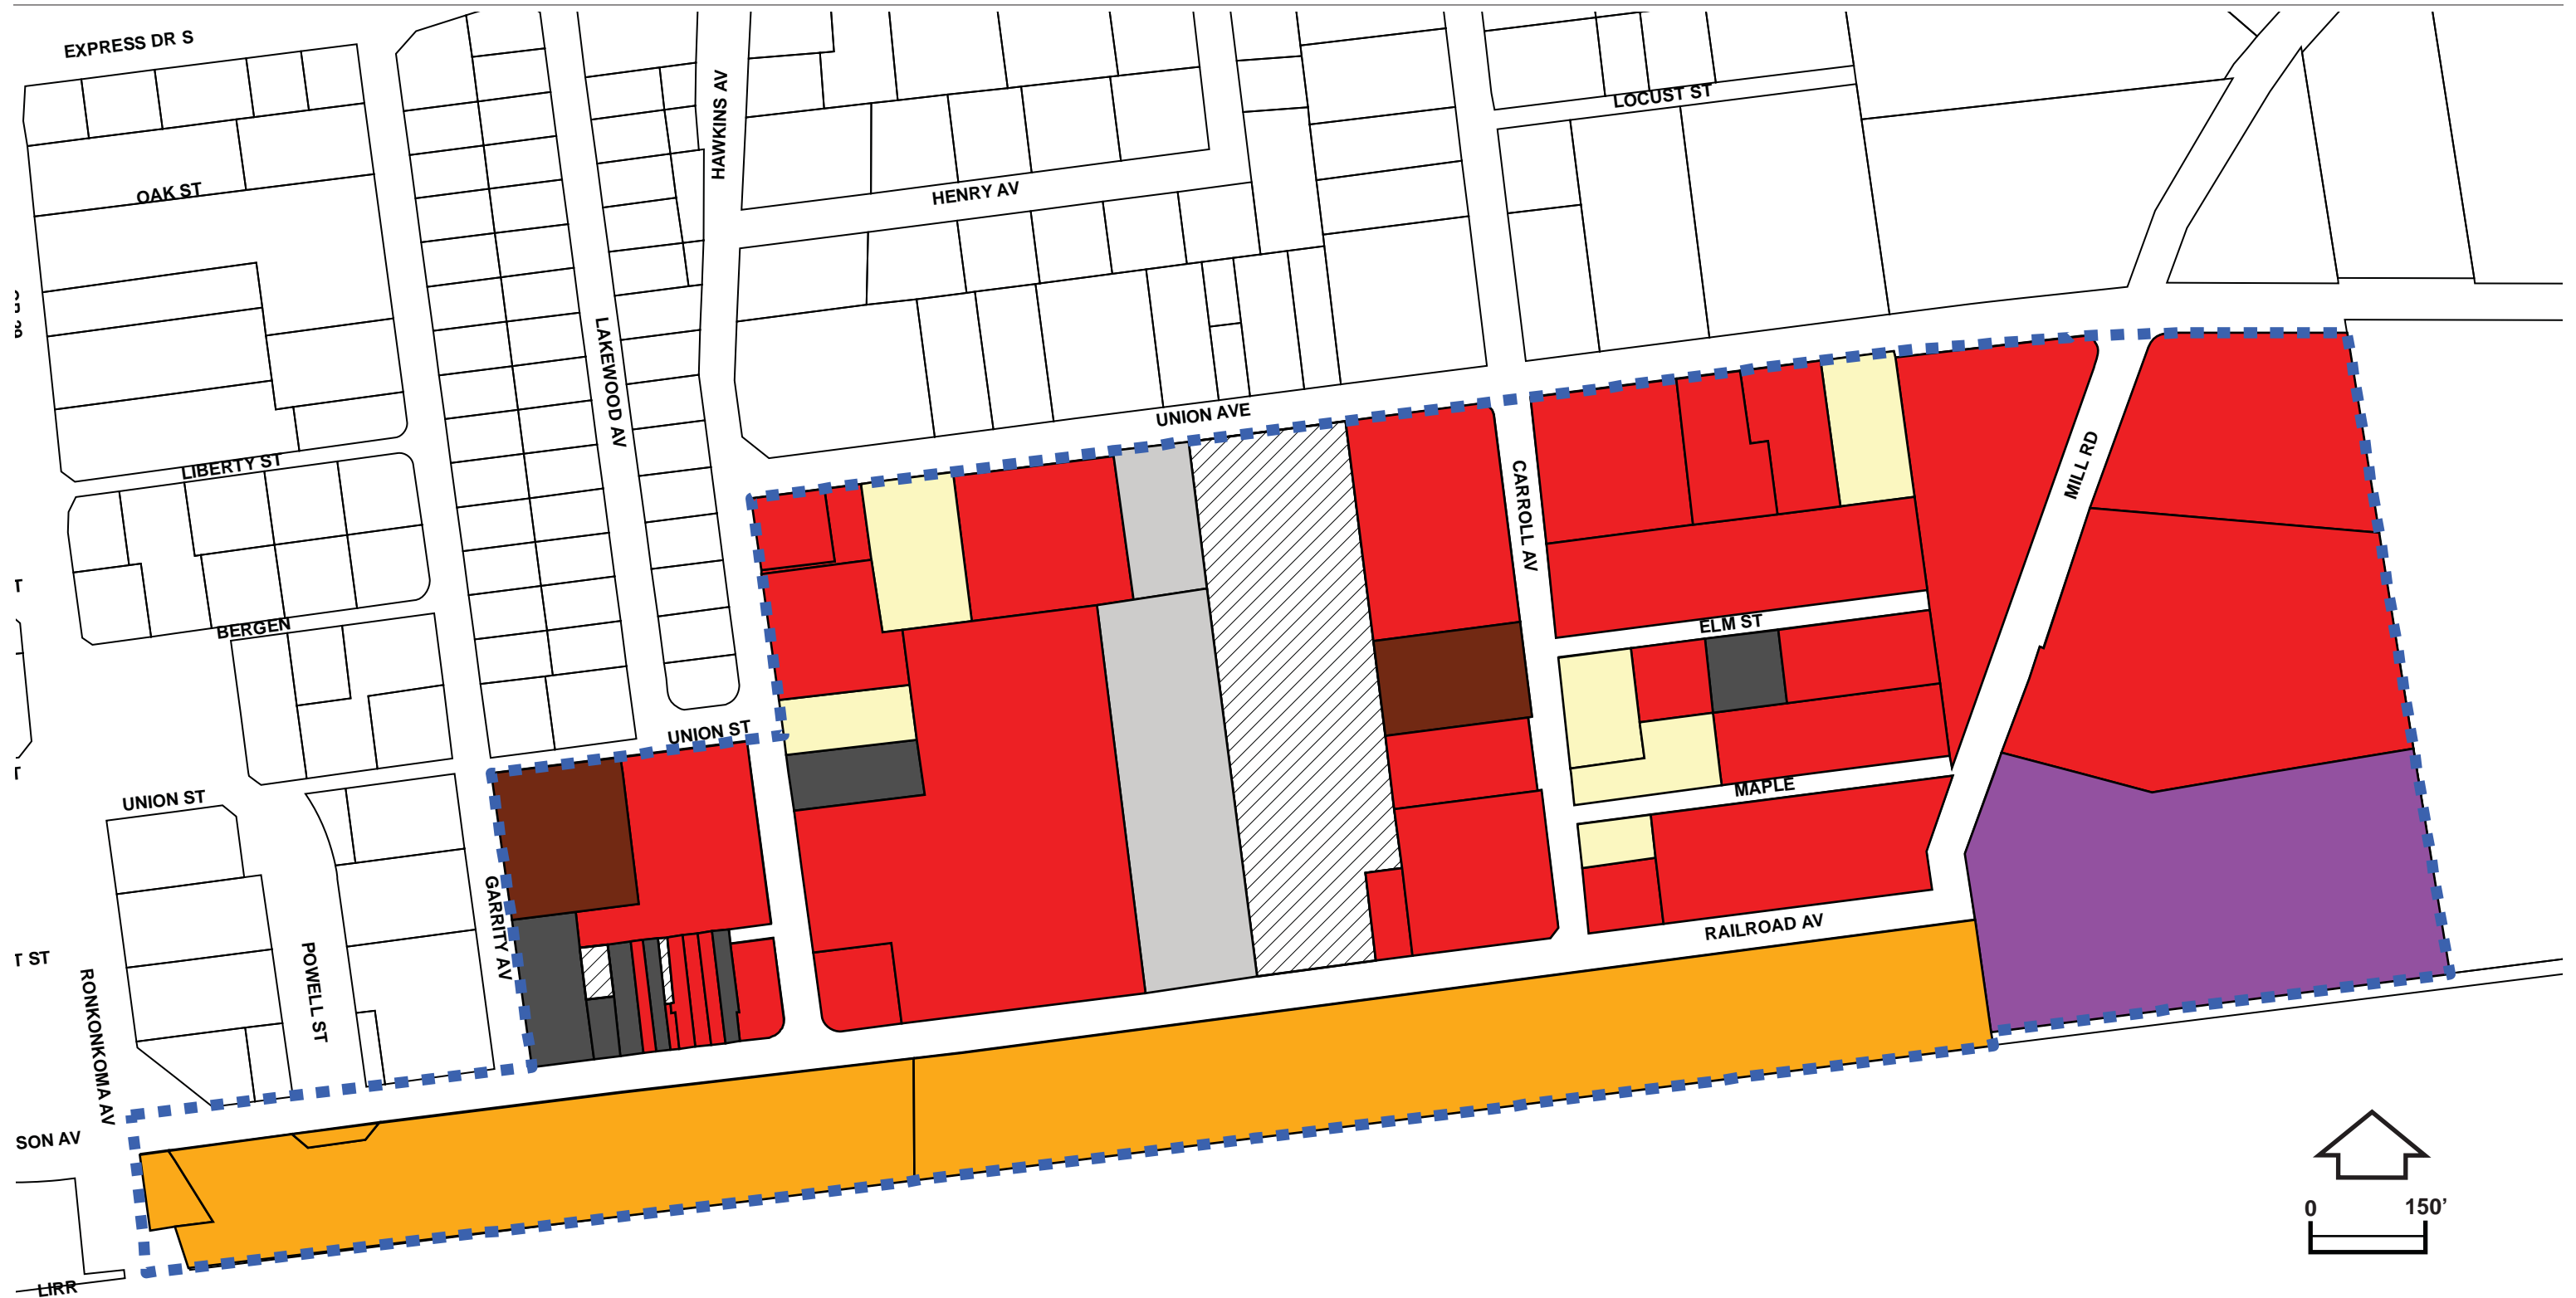
FIGURE  
3

Existing Land Use

As previously discussed, a total of seven tax parcels were observed to contain vacant and partially vacant buildings (representing approximately 5.5 percent of the total building area [gfa] within the Study Area). Three tax parcels were identified as vacant, one via the field survey and two additional lots via aerial photography and GIS data, as these two parcels were not visible from publicly-accessible locations.<sup>2</sup> The photographs below illustrate examples of vacant buildings and properties within the Study Area (for additional photographs of vacant buildings and properties within the Study Area, refer to Appendix B). Figure 3 identifies the vacant buildings and properties observed in the Study Area.

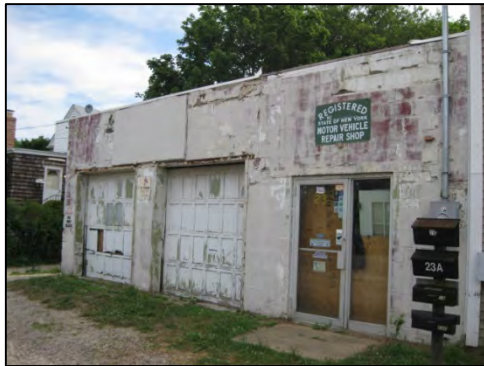
**Photograph No. 1:** View of vacant building along Railroad Avenue

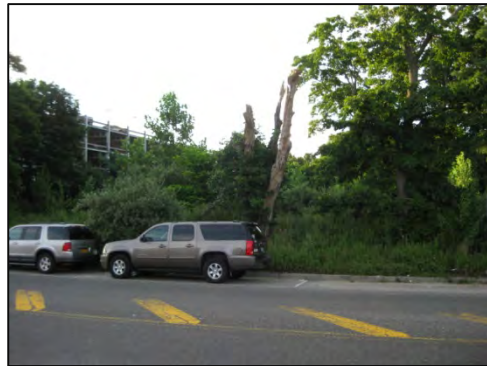
**Photograph No. 2:** View of vacant property along Railroad Avenue.

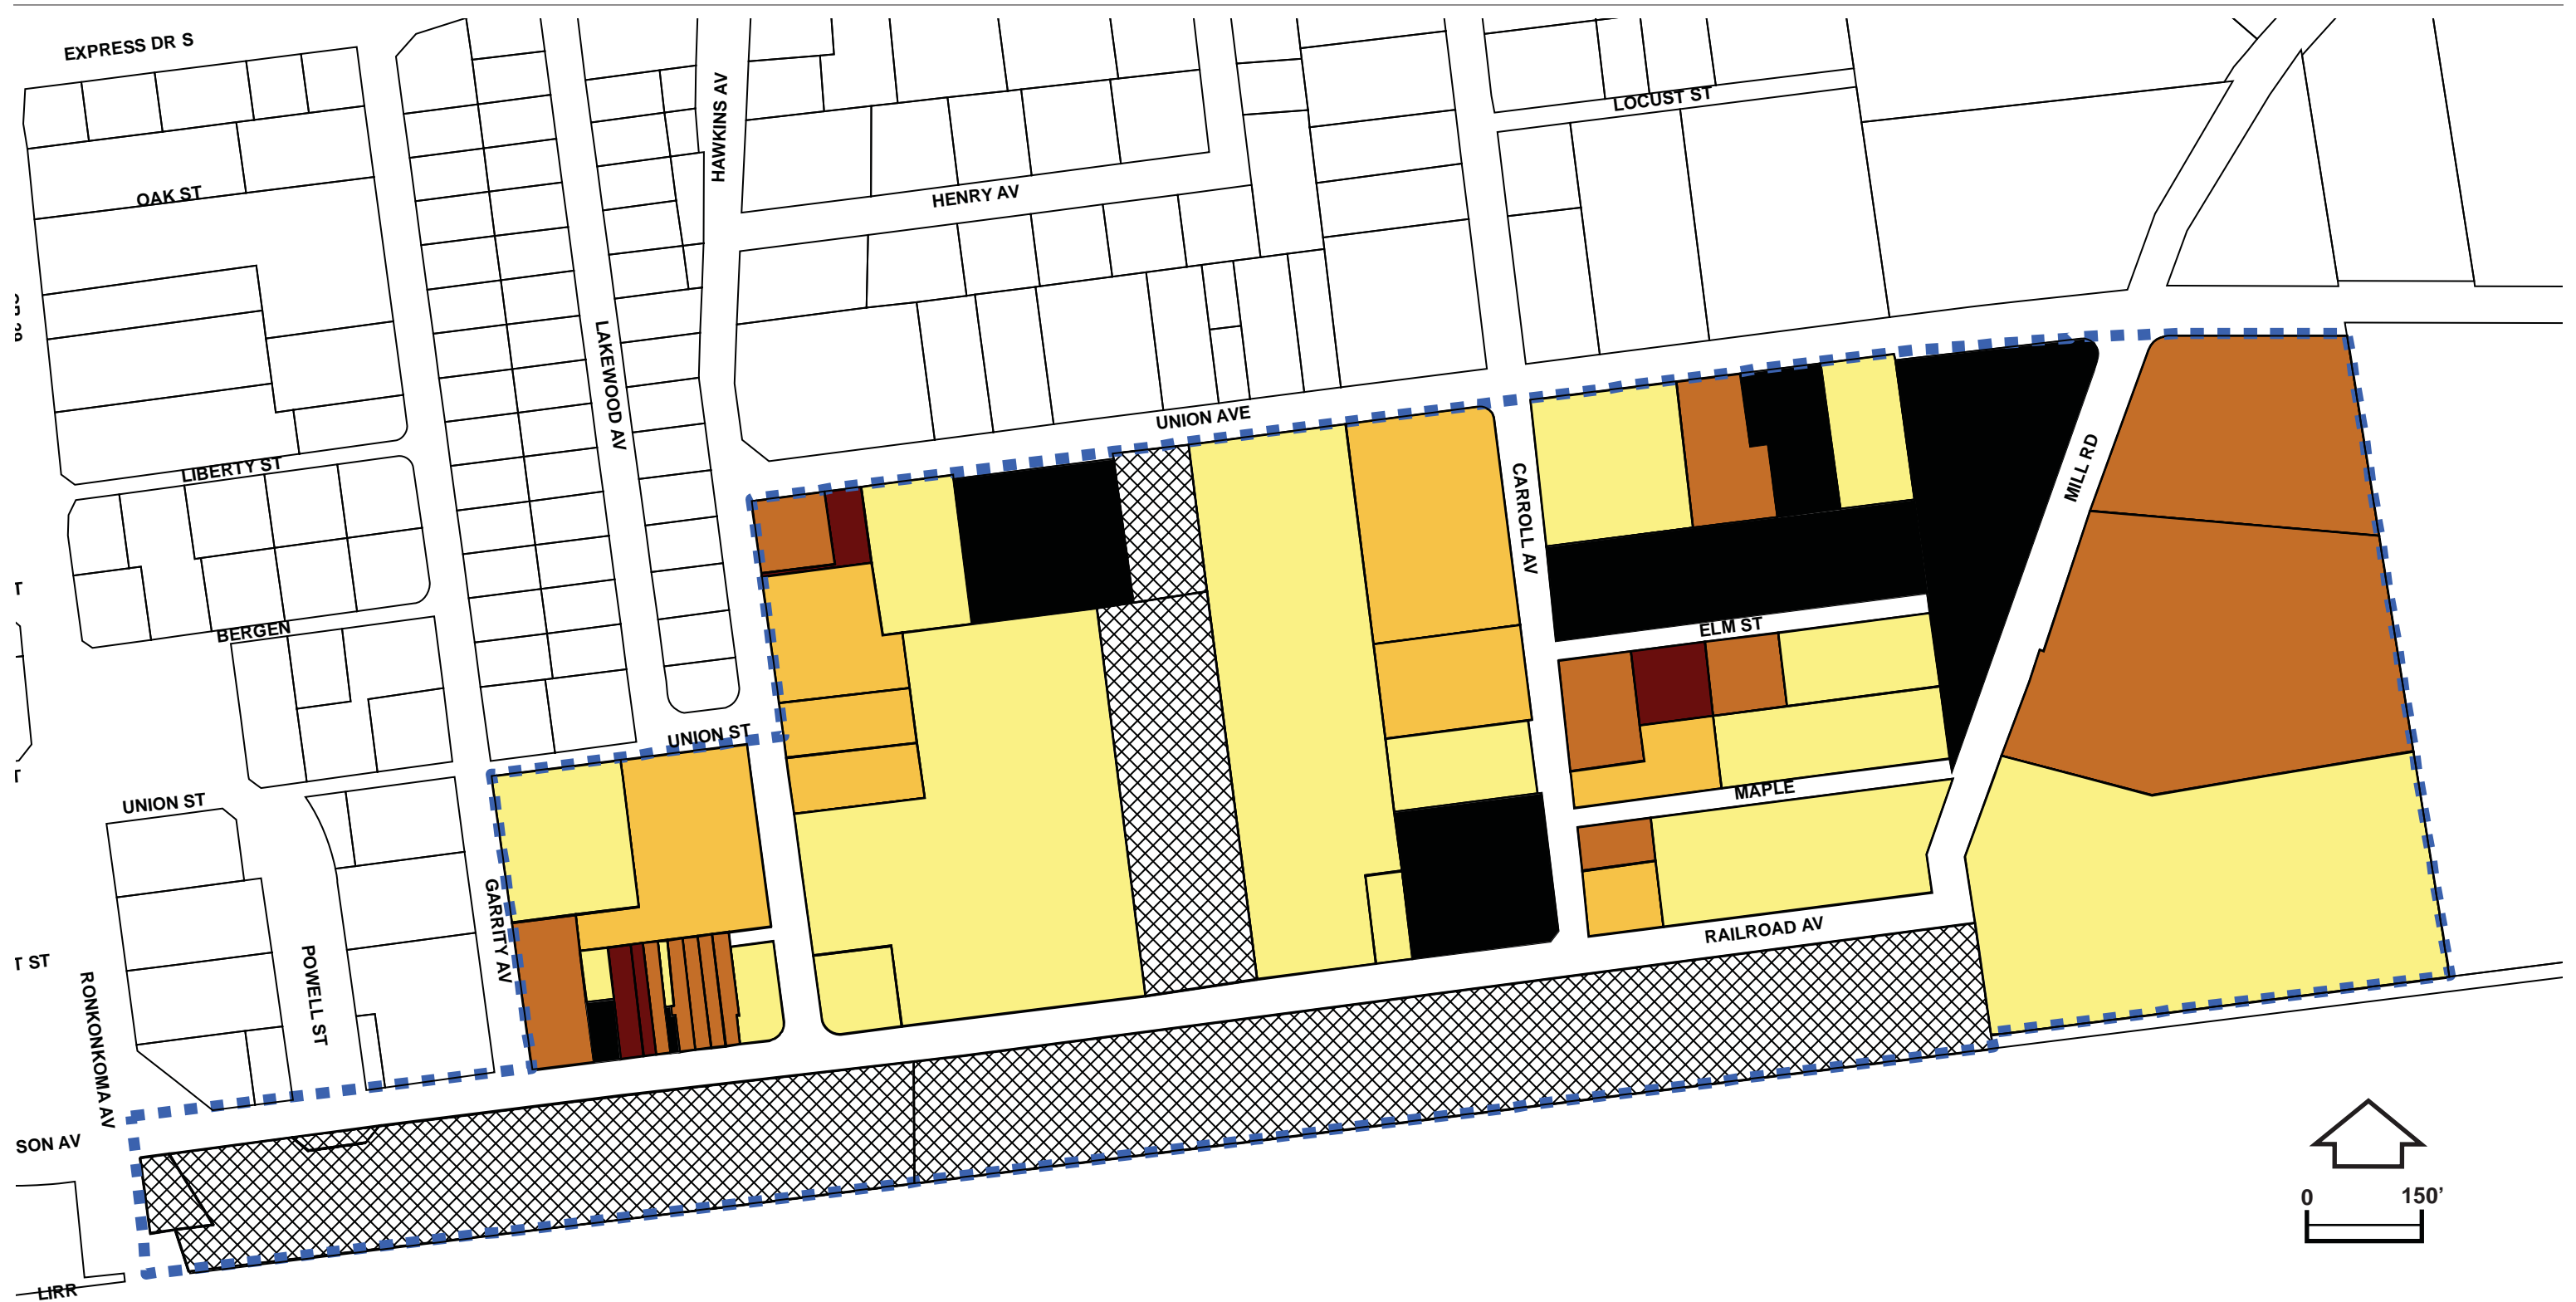
FIGURE  
5

not be feasible to achieve the maximum permitted development on any individual lot due to particular site conditions such as lot configuration, frontage, parking requirements, etc. Nonetheless, this analysis provides an indication of the extent of unrealized development potential within the Study Area. Figure 5 and Table 7 below identify tax parcels within the Study Area that are underdeveloped when compared to estimated maximum calculated permitted gross floor area.

Vacant Tax Parcel
Underutilized Tax Parcel

### Floor-to-Area Ratio Utilization in the Study Area, by Tax Parcel

As indicated in Table 7, various tax parcels are completely underutilized (i.e., they have no built space at all), while many other parcels feature some built space but could potentially allow for significant additional development potential per the Town of Brookhaven zoning code. Specifically, 11 tax parcels (which have the potential for approximately 187,981± square feet of gross floor area) are vacant while 30 tax parcels are partially developed, but have a development potential of an additional 193,775± square feet of gross floor area. This totals an estimated 381,755± square feet of actual gross floor area underutilization. As indicated in Figure 5, underutilized permissible FAR is prevalent throughout the Study Area, especially along the primary transportation corridors (i.e., Railroad and Union Avenues) and along secondary streets (i.e., Garrity, Hawkins, and Carroll Avenues and Mill Road). Such underutilization of allowable building development<sup>6</sup> indicates significant unrealized economic activity (i.e., job creation and property tax revenue) in the Study Area, given the presence of the Ronkonkoma LIRR Station.

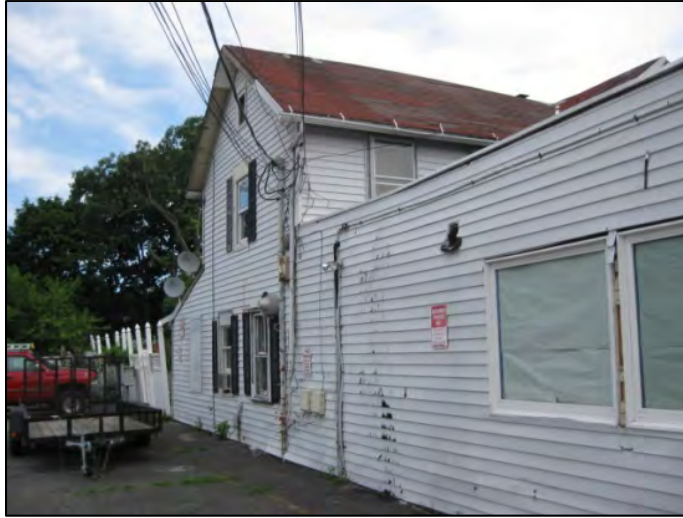
The deterioration of buildings and other structures was observed during the field surveys. Observed deterioration include poor condition of roofs, windows, and siding; deterioration of façade and masonry features; fencing that was falling down and/or in disrepair; and lack of paved driveway areas. Photograph No. 3 provides an example of observed deterioration (for additional photographs of building deterioration in the Study Area, refer to Appendix B).

**Photograph No. 3:** View of a deteriorated mixed-use commercial and residential structure along Garrity Avenue.

Deterioration poses the potential for unsafe conditions and creates a visually unappealing appearance. This can hinder economic growth by discouraging private investment and, thereby, limiting job and property tax revenue generation.

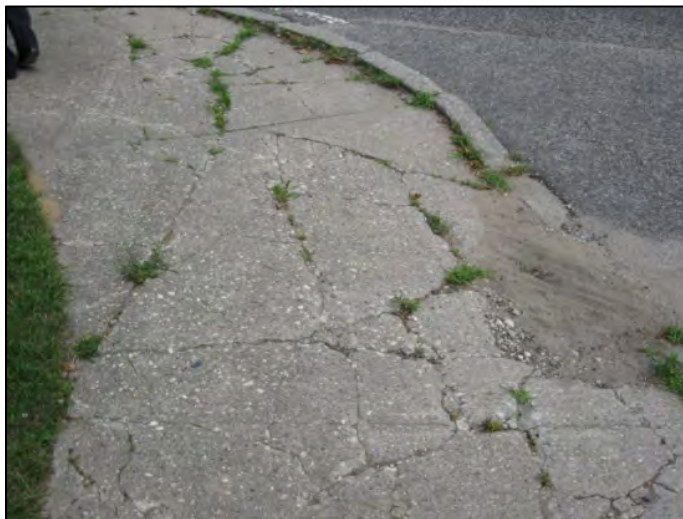
In many locations within the Study Area, particularly along Railroad Avenue, sidewalk and curb areas were observed to be in disrepair and, in some cases, non-existent. Compounding this problem is overgrowth of vegetation; these issues are illustrated in the photograph below.

**Photograph No. 4:** View of deteriorated sidewalk/curb area at Union Avenue and Mill Road.

Inadequate sidewalk and curb areas hinder pedestrian activity, create inefficiencies in pedestrian circulation (along with creating potentially dangerous conditions for pedestrians), contribute to the visual blight within the Study Area. Overall, the lack of pedestrian activity in and around the LIRR Ronkonkoma Station contributes to the economic stagnation within the Study Area.

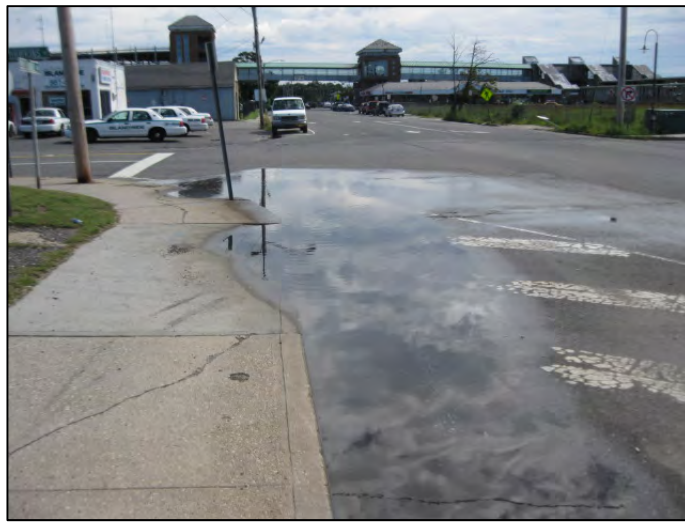
Observations and recorded complaints of pooling water along roads within the Study Area indicate that drainage infrastructure is inadequate, as shown below in Photograph No. 5.

**Photograph No. 5:** View of pooling water along Railroad Avenue.

Lack of such infrastructure contributes to a poor visual and aesthetic appearance, can discourage private investment in the area, and can also contribute to public health threats (e.g., mosquito infestation).

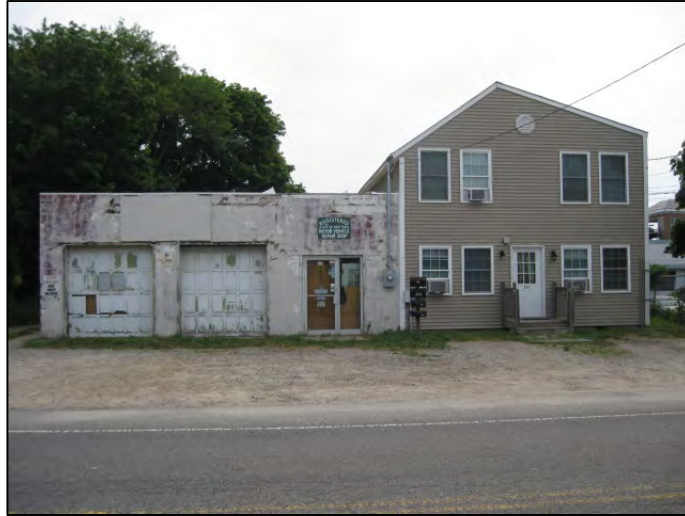
The Study Area features a number of intensive commercial uses (including automobile repair and service businesses) interspersed with low-density (single-family) residential uses. Photograph No. 6 below demonstrates such land uses proximate to one another (for additional photographs depicting the general character of the Study Area, refer to the Photograph Log in the Appendix B).

**Photograph No. 6:** View of adjoining automotive-related business and residential uses along Hawkins Avenue.

Such land uses do not complement one another, and produce a disjointed and inefficient land use pattern. This detracts from the quality of the residential environment as well as the economic vitality of the area, resulting in lost potential for job and property tax revenue generation.

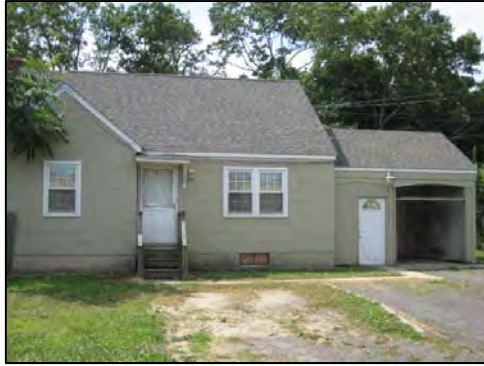
**Photograph 7:** View of abandoned residence along Elm Street.

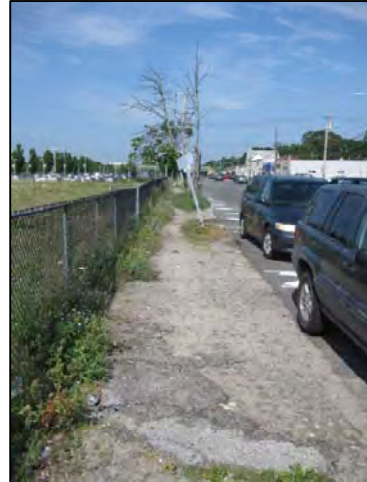
**Photograph 8:** View of deteriorated sidewalk areas along Railroad Avenue.

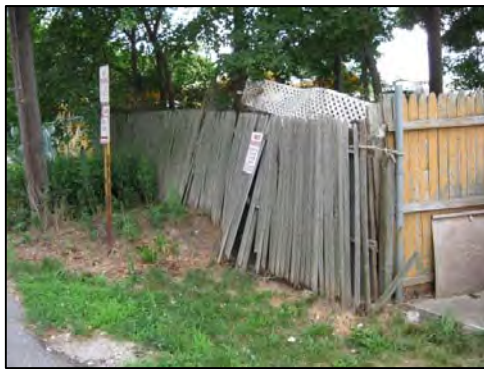
**Photograph 9:** View of deteriorated fencing along Garrity Avenue.

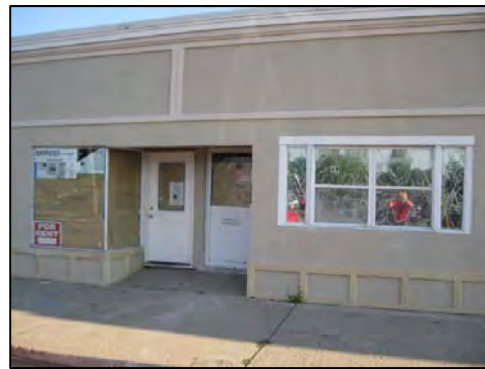
**Photograph 10:** View of vacant commercial building along Railroad Avenue.

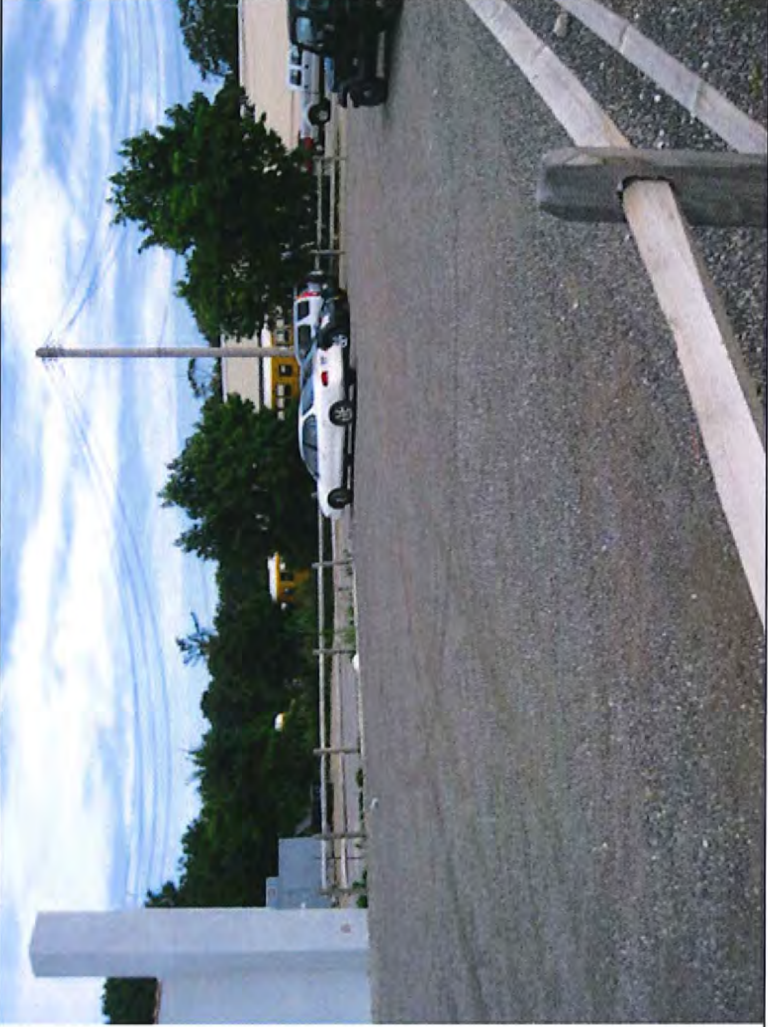
**Photograph No. 5**

SCTM No.:	Owner:	Land Use:	Zoning:	Lot Size (acres):	Comments:
799-3-34	Gregory J. Mensch	Commercial (Parking for Commercial Use)	J6	0.18±	Property utilized for parking, likely for employees of the bus depot.

View of parcel from Railroad Avenue.

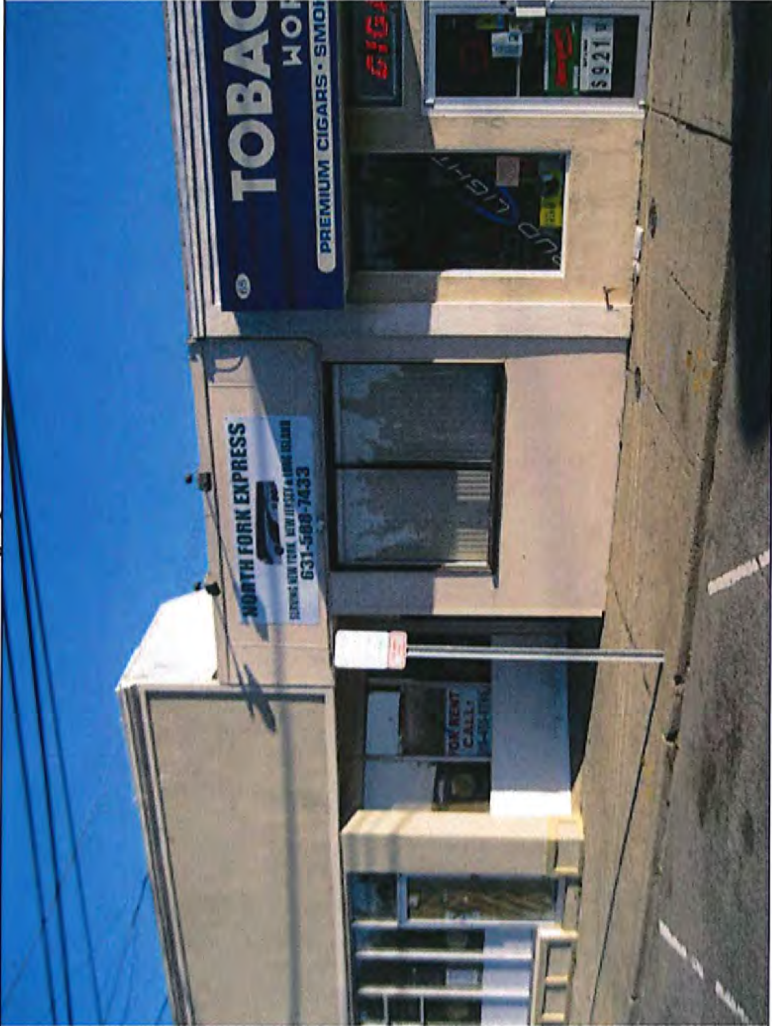
Photograph No. 14

SCTM No.:	Owner:	Land Use:	Zoning:	Lot Size (acres):	Comments:
799-3-39	63 Railroad Avenue, LLC	Commercial	J6	0.08±	Commercial building observed to be in good condition.

View of property frontage from Railroad Avenue

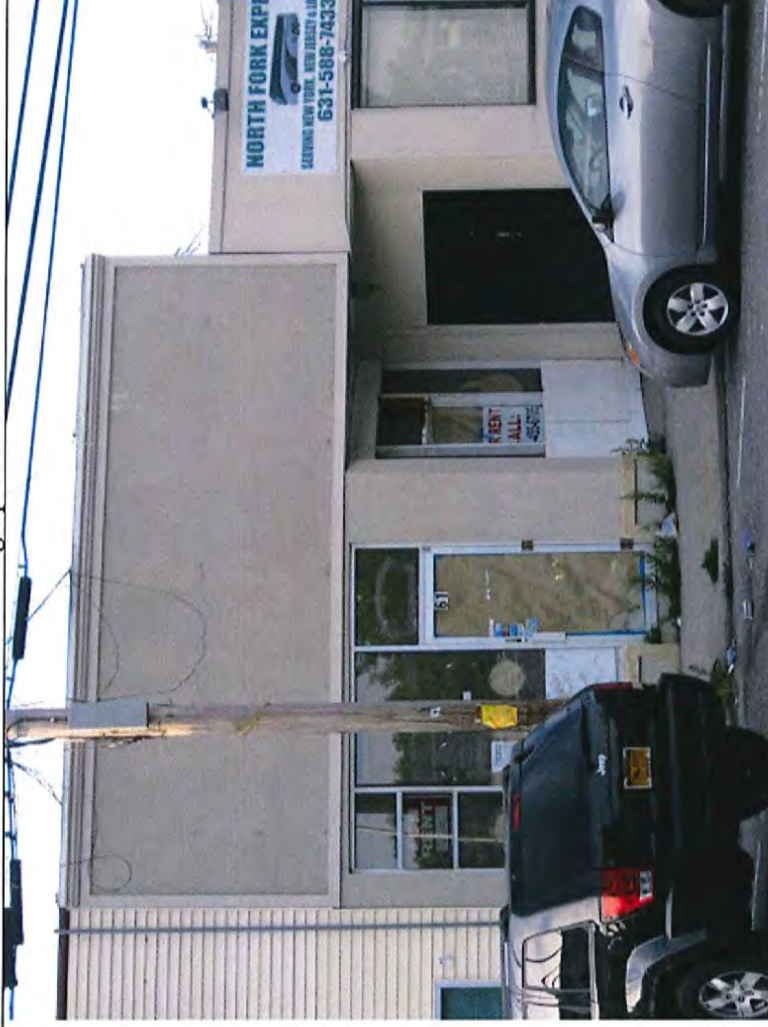
Photograph No. 15

SCTM No.:	Owner:	Land Use:	Zoning:	Lot Size (acres):	Comments:
799-3-40.2	61 Property Corp	Commercial	J6	0.02±	Vacant commercial building, observed to be recently renovated

View of site frontage from Railroad Avenue

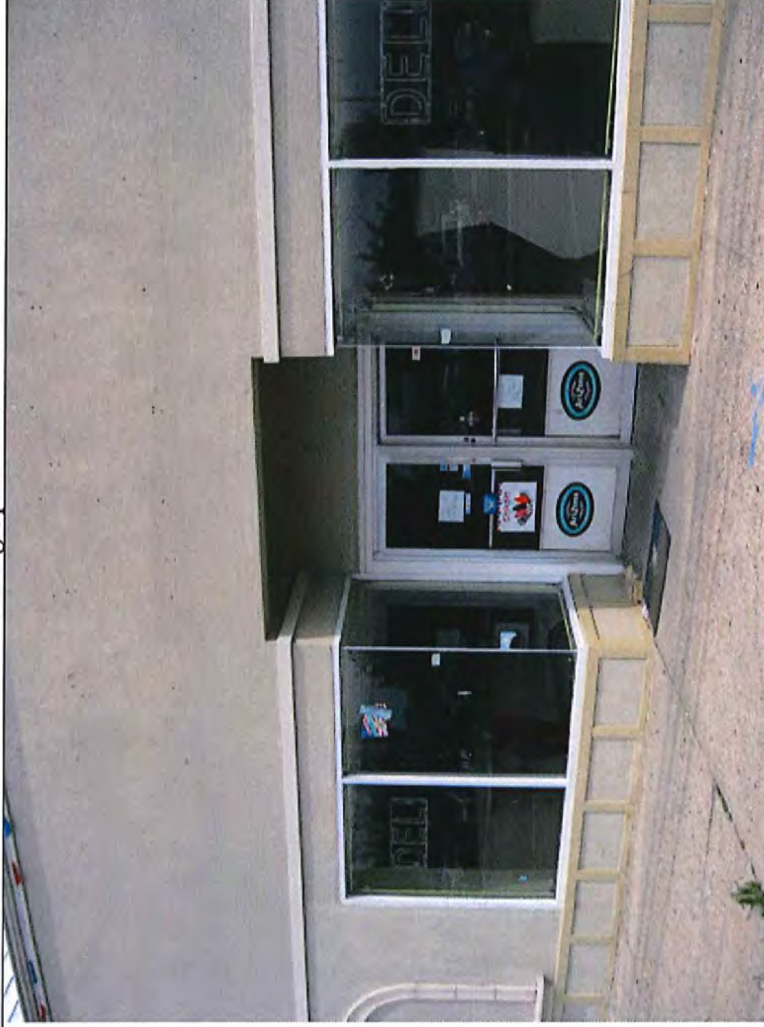
Photograph No. 17

SCTM No.:	Owner:	Land Use:	Zoning:	Lot Size (acres):	Comments:
799-3-42	55 Property Corp	Commercial	J6	0.11±	Vacant commercial building, observed to be recently renovated

View of frontage along Railroad Avenue

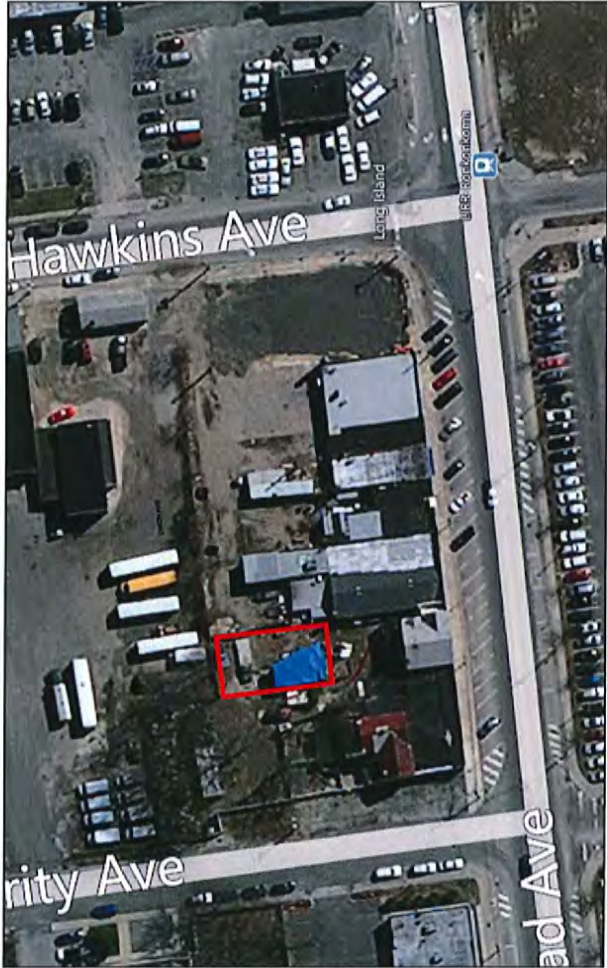
Aerial No. 2

SCTM No.:	Owner:	Land Use:	Zoning:	Lot Size:	Comments:
799-3-33.2	55 Property Corp	Commercial (Vacant)	J6	0.06±	Not visible from publicly-accessible location Identified as a vacant lot from GIS analysis

Approximate boundaries of subject parcel outlined in red.

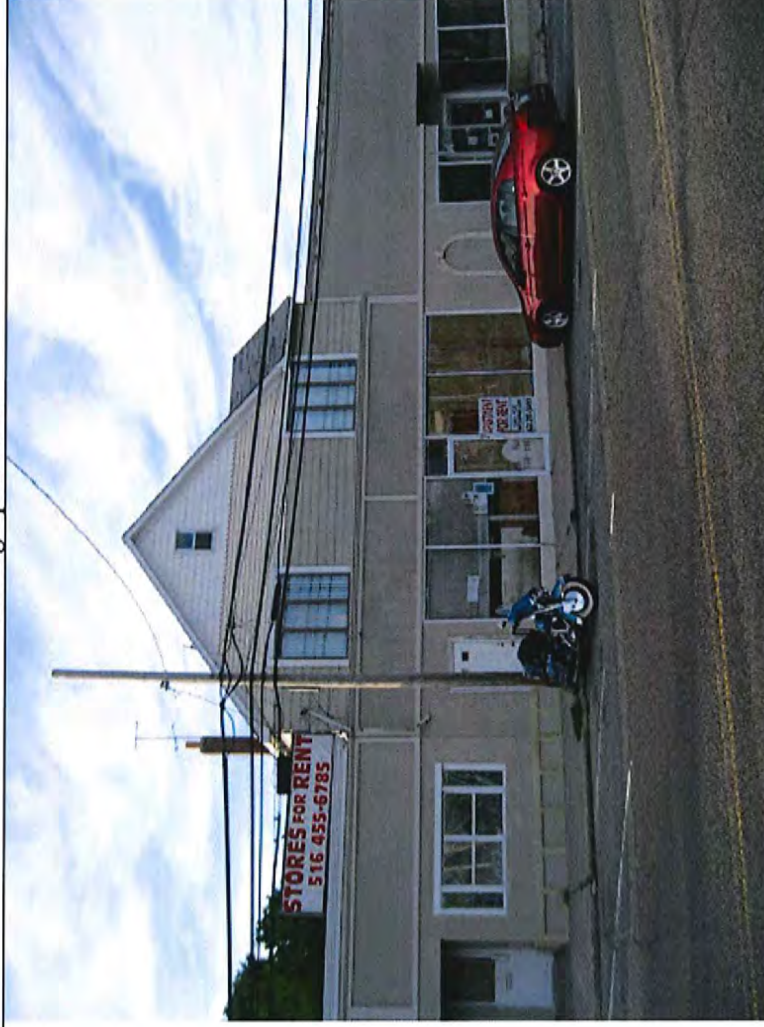
Photograph No. 18

SCTM No.:	Owner:	Land Use:	Zoning:	Lot Size (acres):	Comments:
799-3-43	51 Property Corp	Commercial (Vacant);	J6	0.07±	Vacant commercial building, observed to be recently renovated

View of property frontage along Railroad Avenue

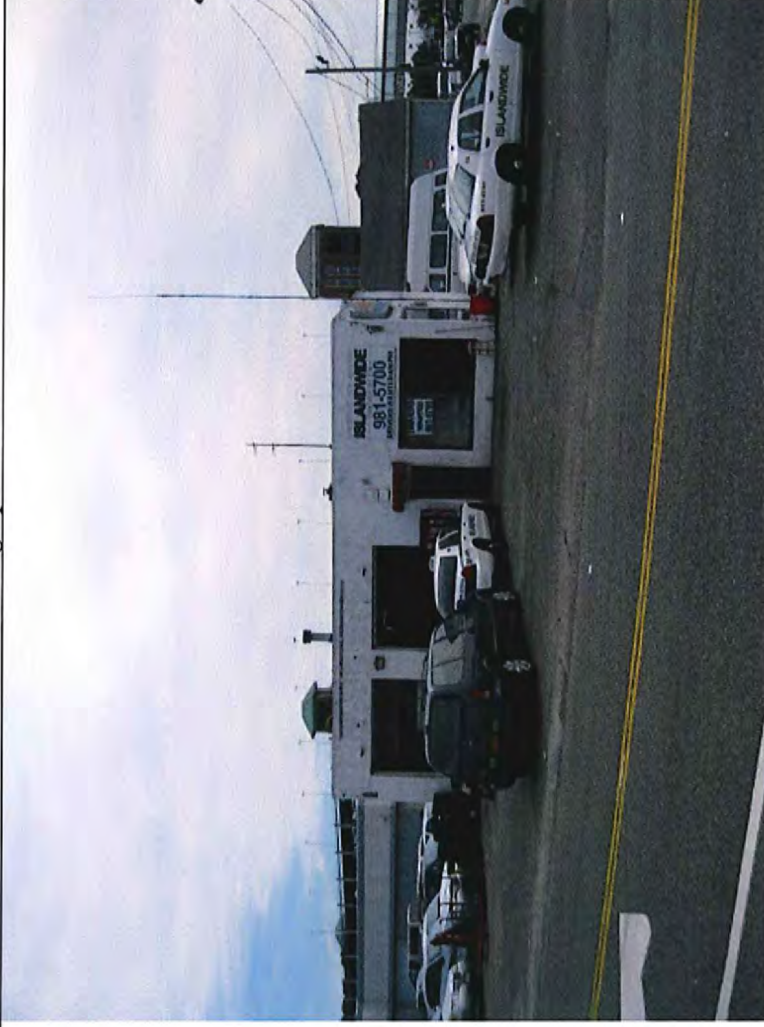
Photograph No. 21

SCTM No.:	Owner:	Land Use:	Zoning:	Lot Size (acres):	Comments:
799-4-44	NHP Realty, LLC	Commercial	J6	0.27±	Taxi / Auto-repair use, with visible building deterioration

View of building frontage along Hawkins Avenue.

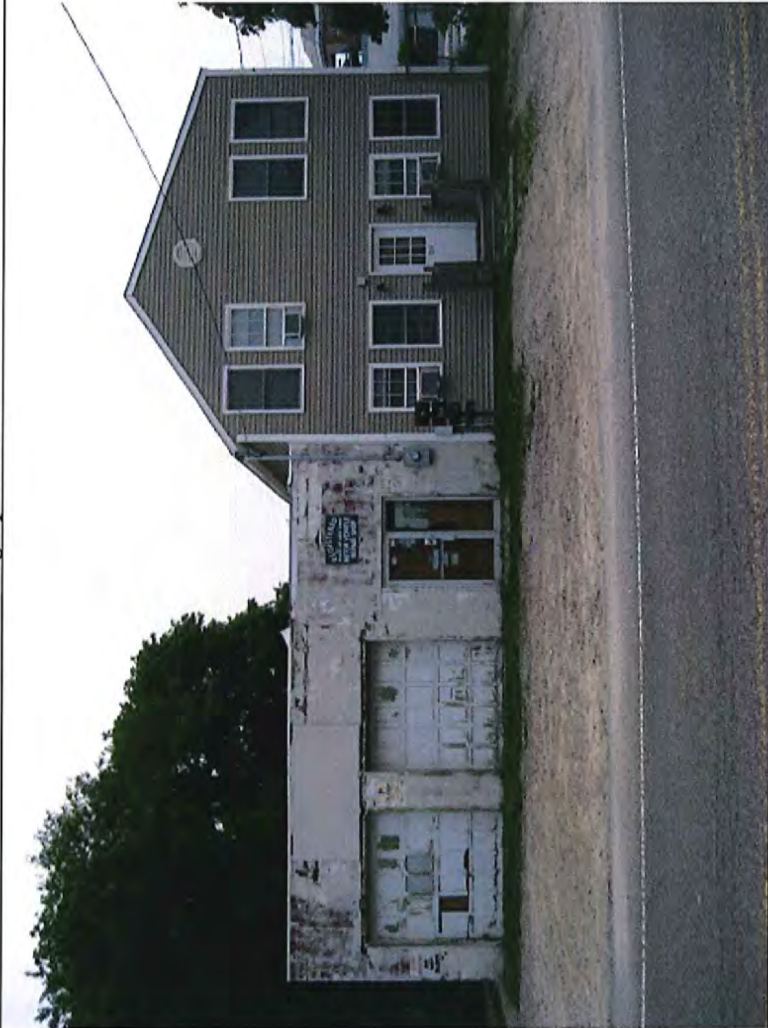
Photograph No. 24

SCTM No.:	Owner:	Land Use:	Zoning:	Lot Size (acres):	Comments:
799-4-48	Margaret Higgins & Jerome Gaynor	Commercial/ Residential	J6	0.31±	Auto-repair portion vacant and façade is in disrepair with deteriorating masonry, peeling paint, missing wood sections on garage doors. Continuous curb cut leading to unpaved driveway and parking area. Residence observed to be in good condition

View of property from Hawkins Avenue.

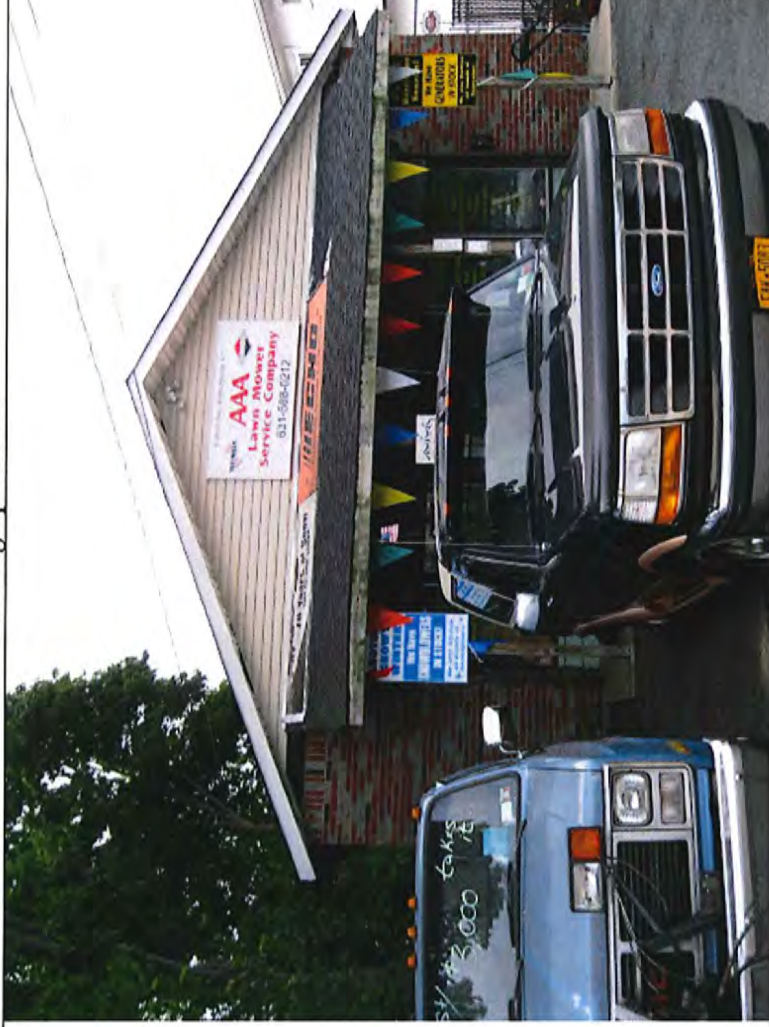
Photograph No. 30

SCTM No.:	Owner:	Land Use:	Zoning:	Lot Size (acres):	Comments:
799-4-53	Carmine E. Dorsi	Commercial	L1	0.13±	Commercial building observed to be in good condition.

View of property from Union Avenue.
