# *The Ronkonkoma HUB Study Area*

Hamlet of Ronkonkoma  
Town of Brookhaven  
New York

**September 2012**

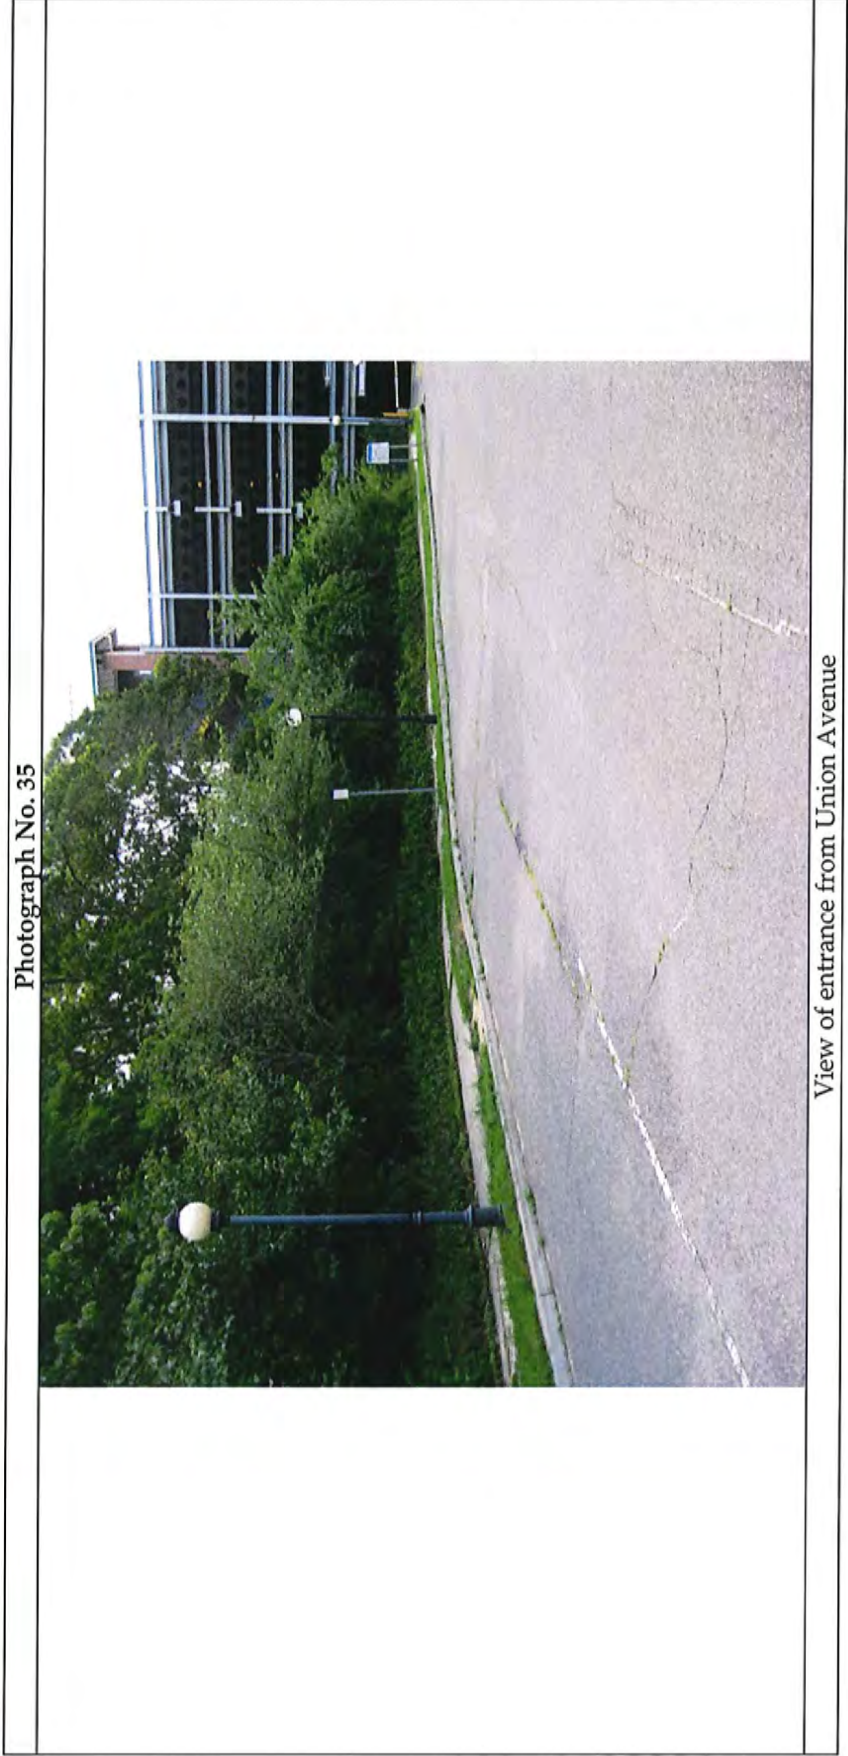
SCTM No.:	Owner:	Land Use:	Zoning:	Lot Size (acres):	Comments:
800-1-28	MTA & R. Bergen David S. Symons	LIRR Parking Deck Entrance	L1	0.47±	None

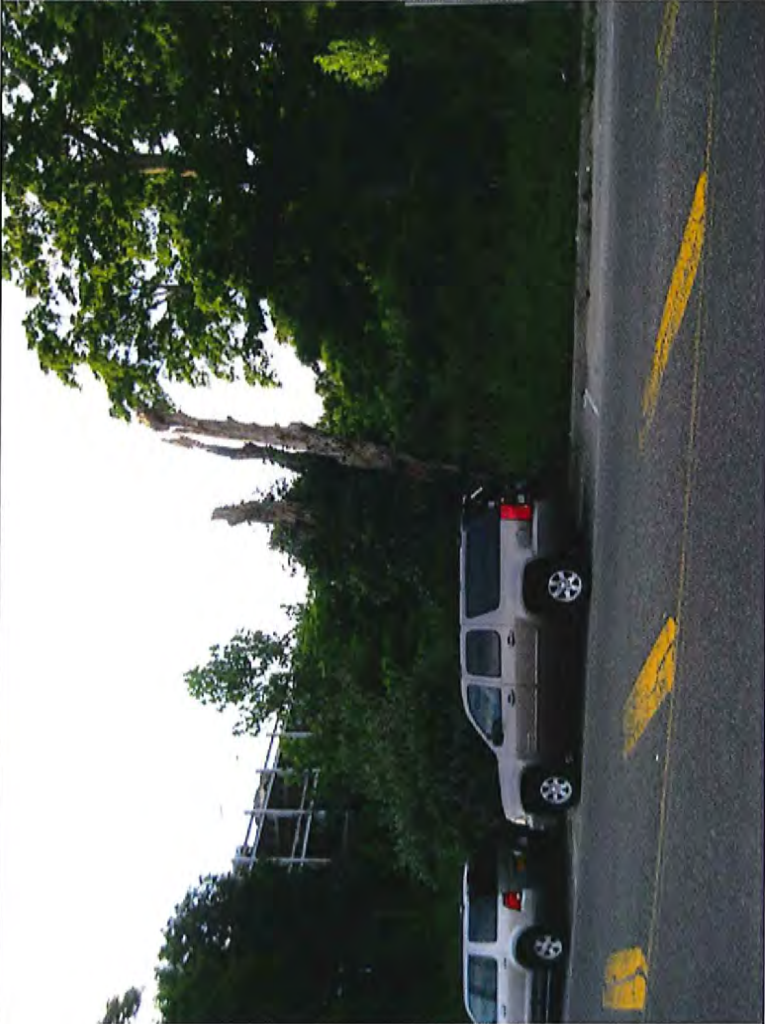
Photograph No. 36

SCTM No.:	Owner:	Land Use:	Zoning:	Lot Size (acres):	Comments:
800-1-35.8	Ronkonkoma Rail Road Properties, LLC.	Wooded/Vacant	L1	3.43±	Undeveloped/wooded parcel

View of property from Railroad Avenue

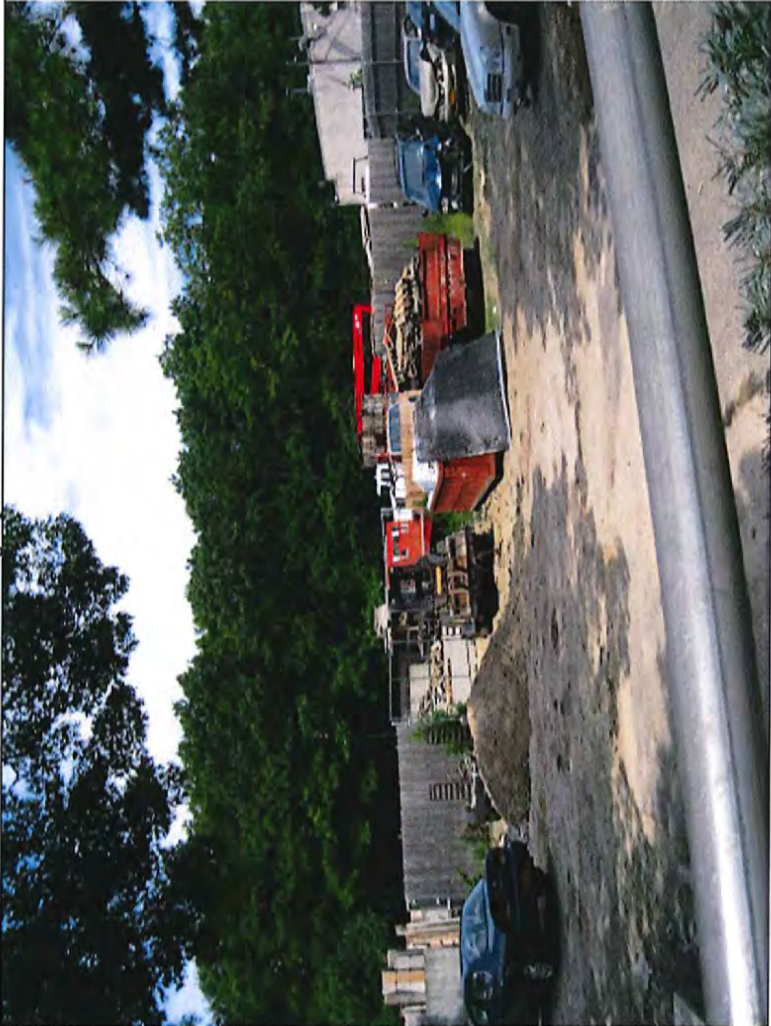
Photograph No. 40

SCTM No.:	Owner:	Land Use:	Zoning:	Lot Size (acres):	Comments:
800-1-34	Nelson Fernandes & Magalhaes Americo	Commercial	L1	0.45±	Open lot for staging/ auto storage (underutilized).

View of property from Carroll Avenue

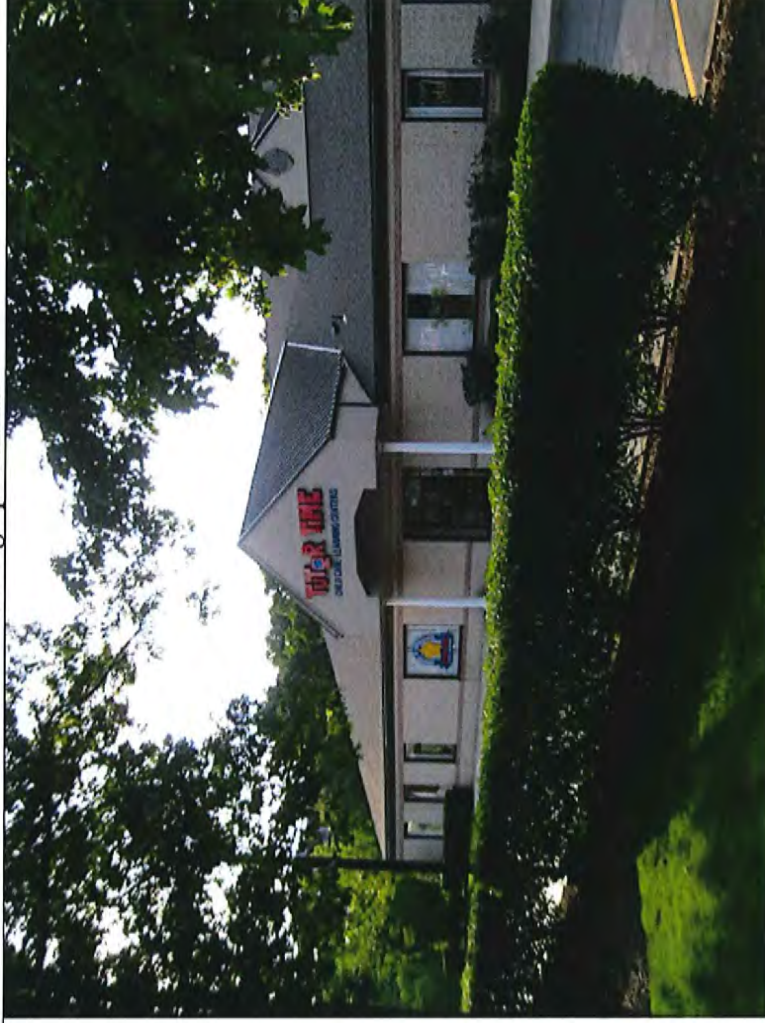
Photograph No. 41

SCTM No.:	Owner:	Land Use:	Zoning:	Lot Size (acres):	Comments:
800-1-35.7	Tudor Station Plaza, LLC c/o Island Estates	Commercial	L1	0.92±	Commercial building observed to be in good condition

View of property from Railroad Avenue

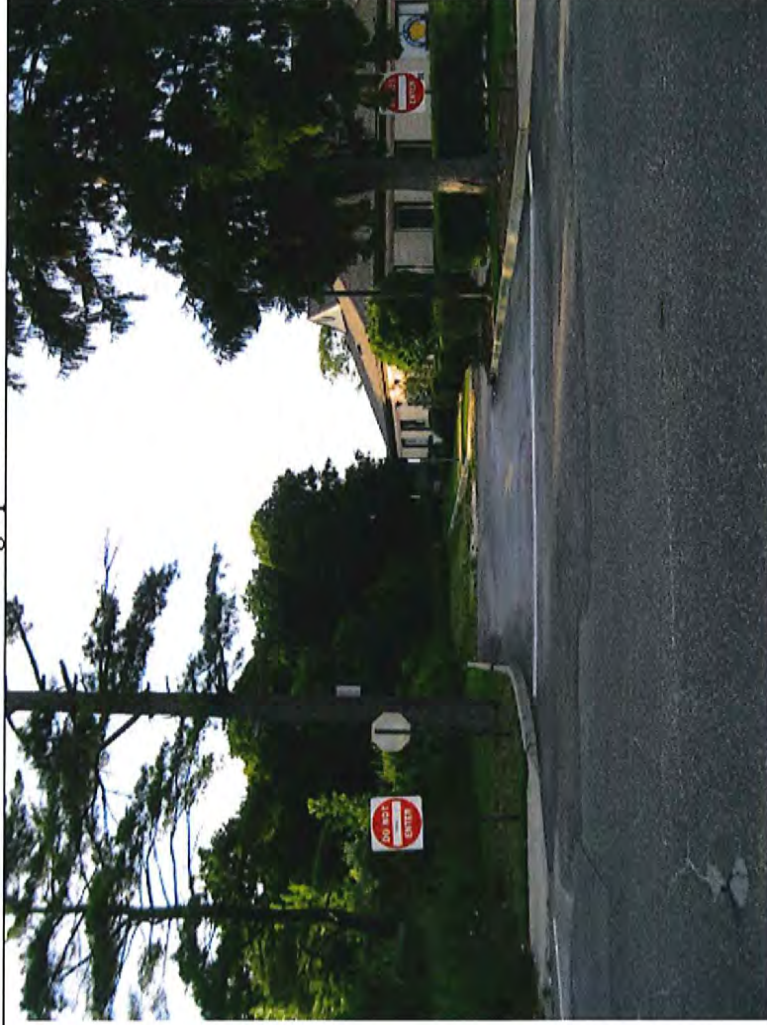
Photograph No. 42

SCTM No.:	Owner:	Land Use:	Zoning:	Lot Size (acres):	Comments:
800-1-35.9	Tudor Station Plaza, LLC c/o Island Estates	Undeveloped/ Wooded	L1	0.14±	Parcel utilized as entrance/exit to day care facility (underutilization)

View of property from Railroad Avenue

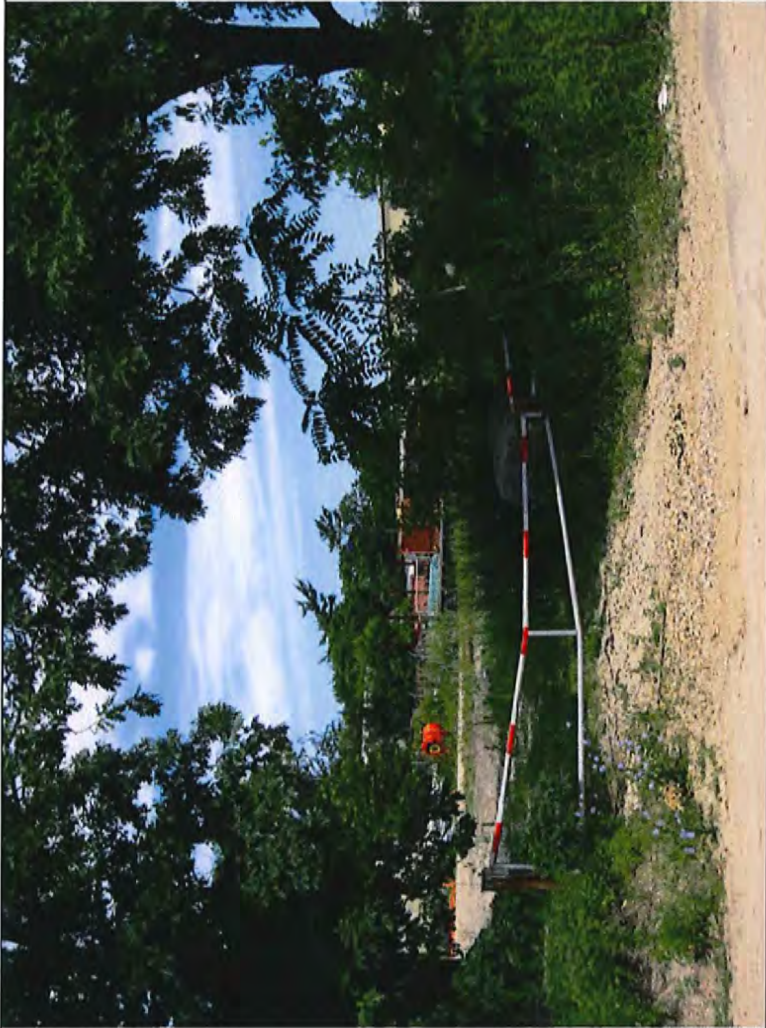
Photograph No. 46

SCTM No.:	Owner:	Land Use:	Zoning:	Lot Size (acres):	Comments:
800-2-19 800-2-22	William A. Mallins	Commercial	L1	0.70± 1.30± (2.0± Total)	Property used for commercial storage/staging (underutilization). Two lots that are used for same purpose. Views of property screened from Mill Road.

View of property from Mill Road

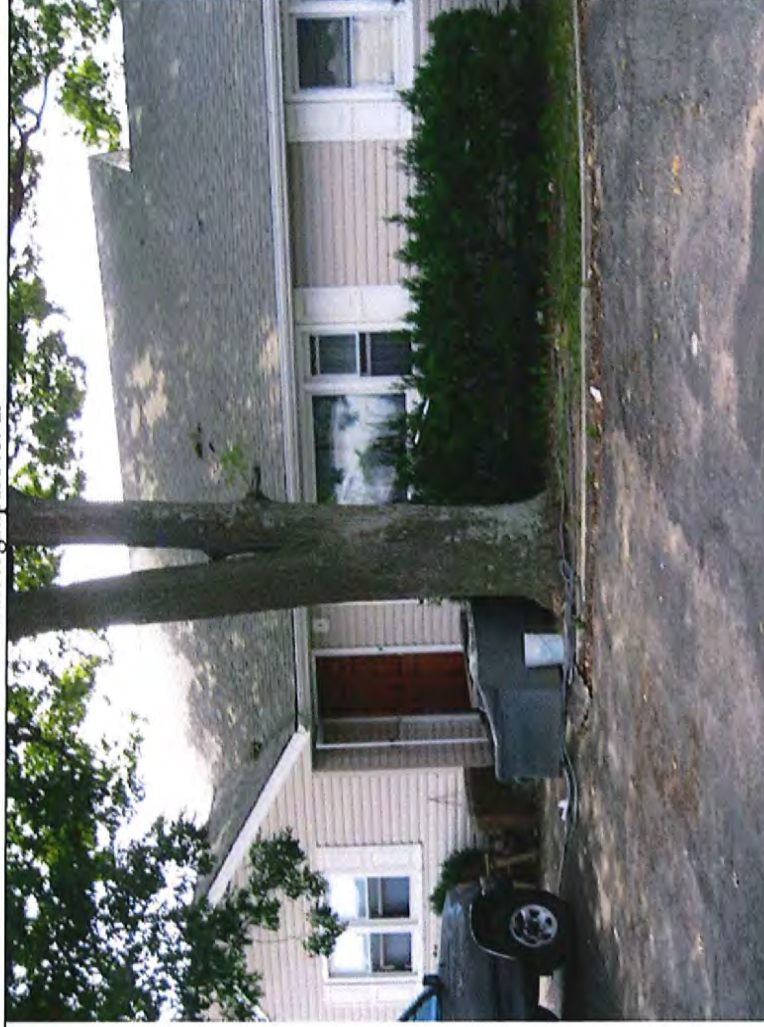
Photograph No. 49

SCTM No.:	Owner:	Land Use:	Zoning:	Lot Size (acres):	Comments:
800-2-12	William and Mildred Mallins	Residential	L1	0.46±	Residence observed to be in good condition.

View of property from Union Avenue.

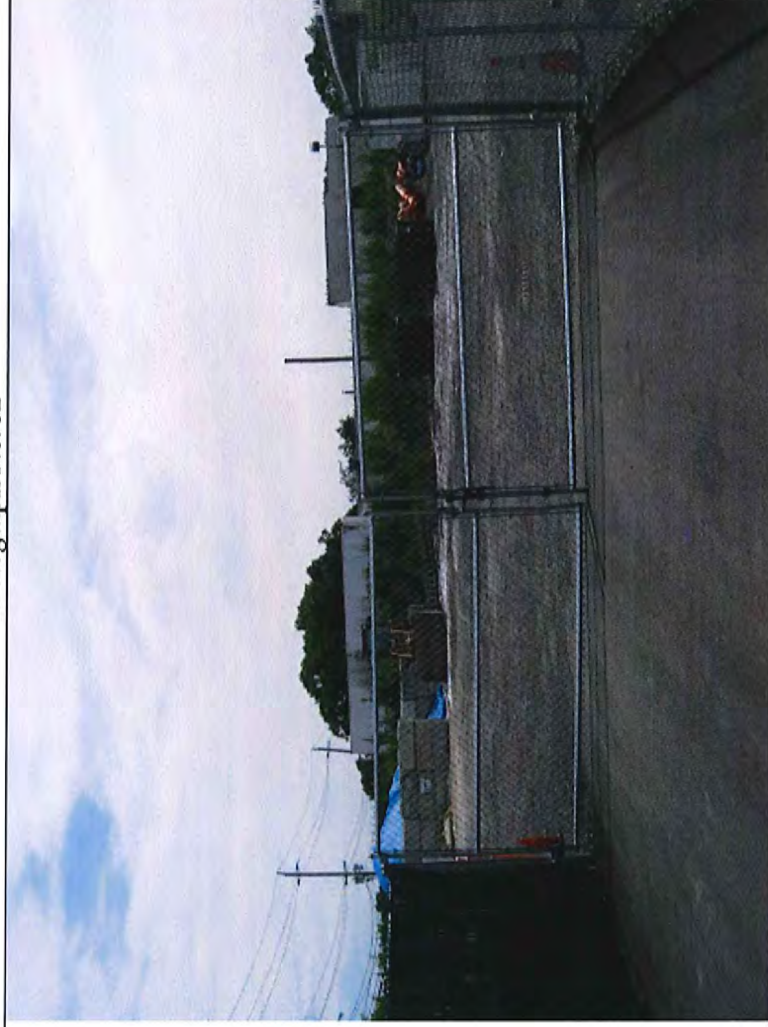
Photograph No. 52

SCTM No.:	Owner:	Land Use:	Zoning:	Lot Size (acres):	Comments:
800-2-9	Holbrook Truck and Equipment Leasing, Inc.	Commercial	L1	0.91±	Commercial storage/staging (underutilized)

View of property from Carroll Avenue.

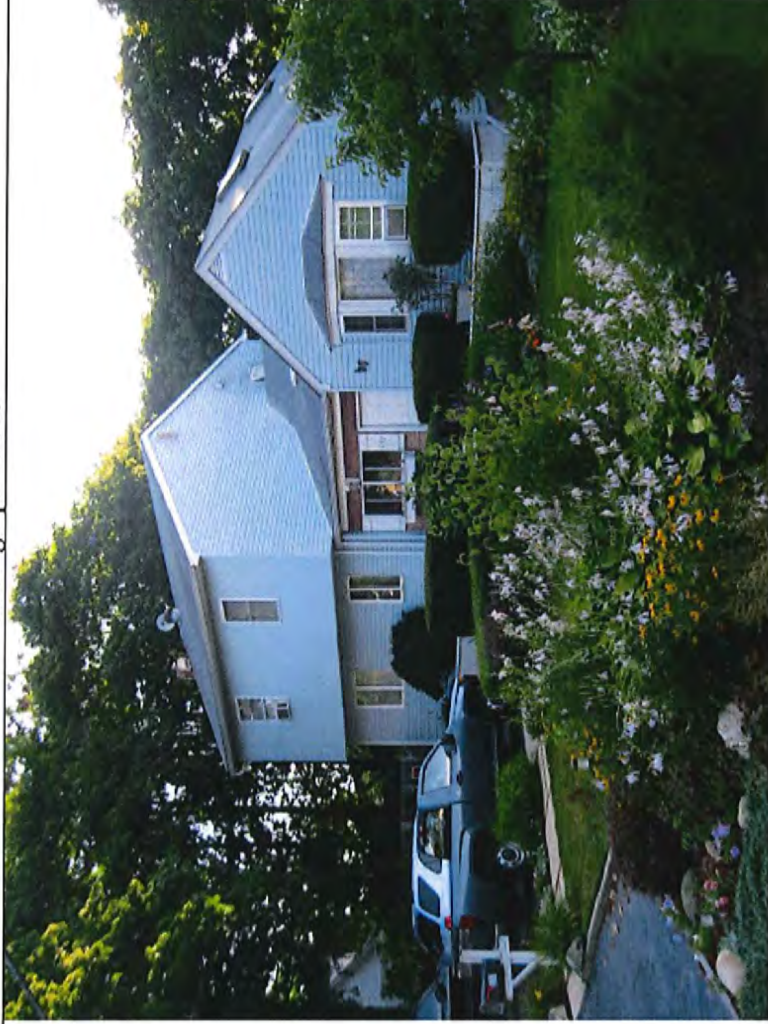
Photograph No. 59

SCTM No.:	Owner:	Land Use:	Zoning:	Lot Size (acres):	Comments:
800-2-17	Joseph Urban	Residential	L1	0.34±	Residence observed to be in good condition

View of property from Carroll Avenue

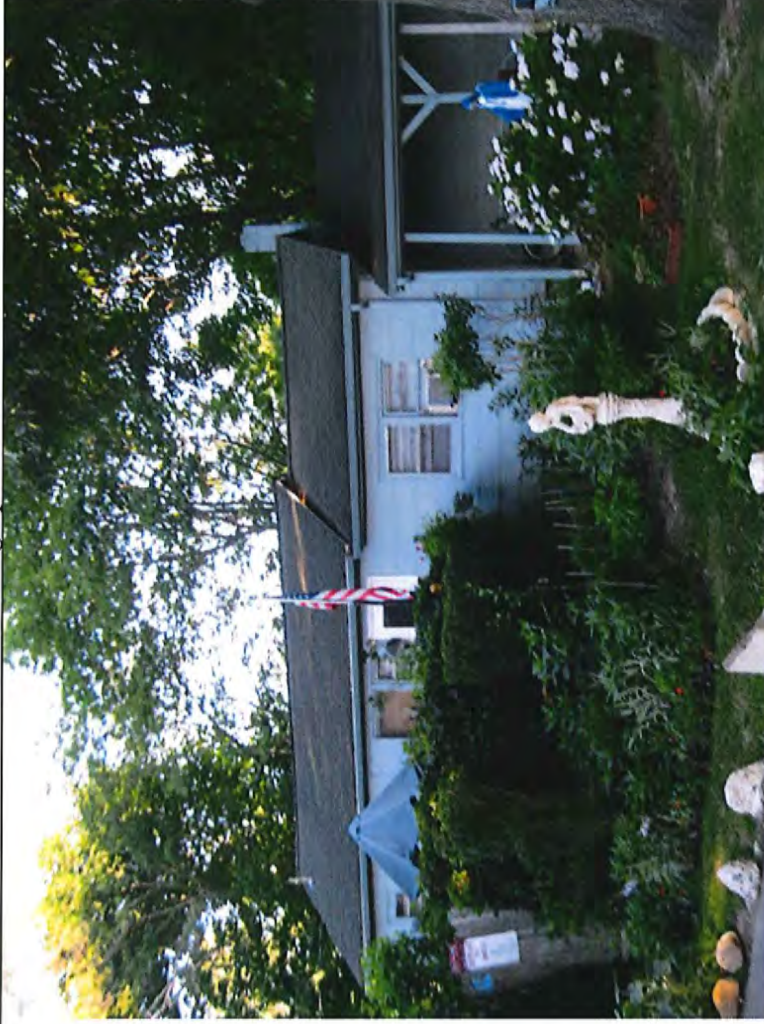
Photograph No. 60

SCTM No.:	Owner:	Land Use:	Zoning:	Lot Size (acres):	Comments:
800-2-18	Calvin C. Lorenz	Residential	L1	0.34±	Residence observed to be in good condition

View of property from Maple Street

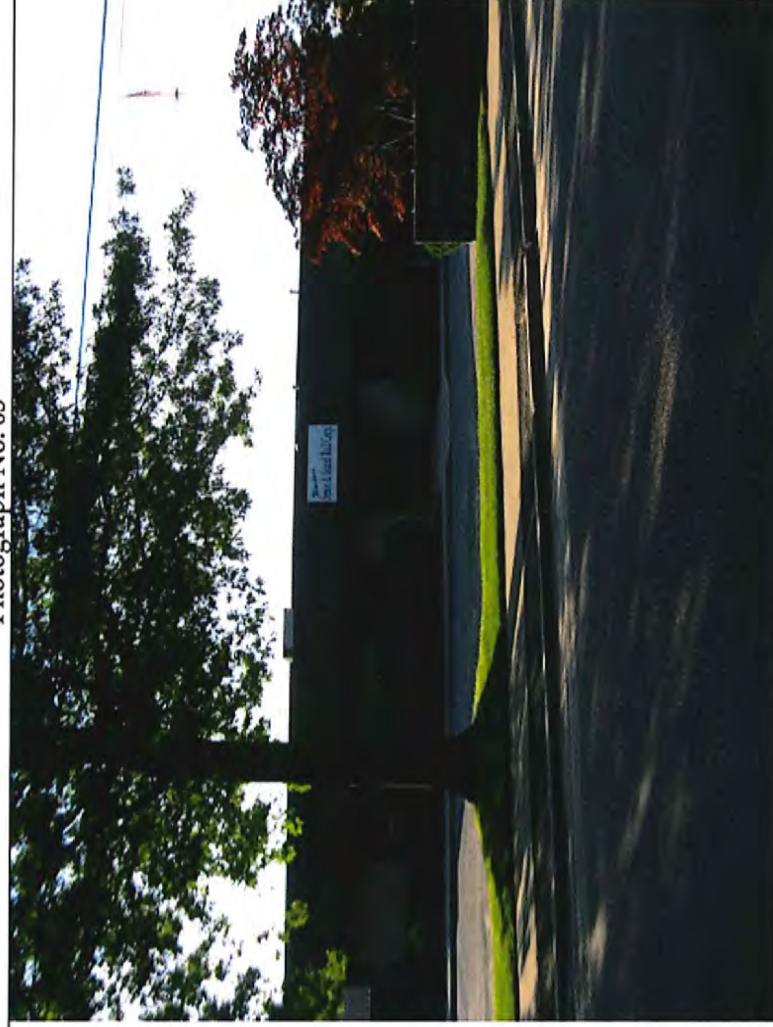
Photograph No. 63

SCTM No.:	Owner:	Land Use:	Zoning:	Lot Size (acres):	Comments:
800-2-28.3	Unified Credit Trust & G&D Oakland & C. Hill Trustee	Commercial	J2	3.74±	Commercial building observed to be in good condition

View of property from Mill Road

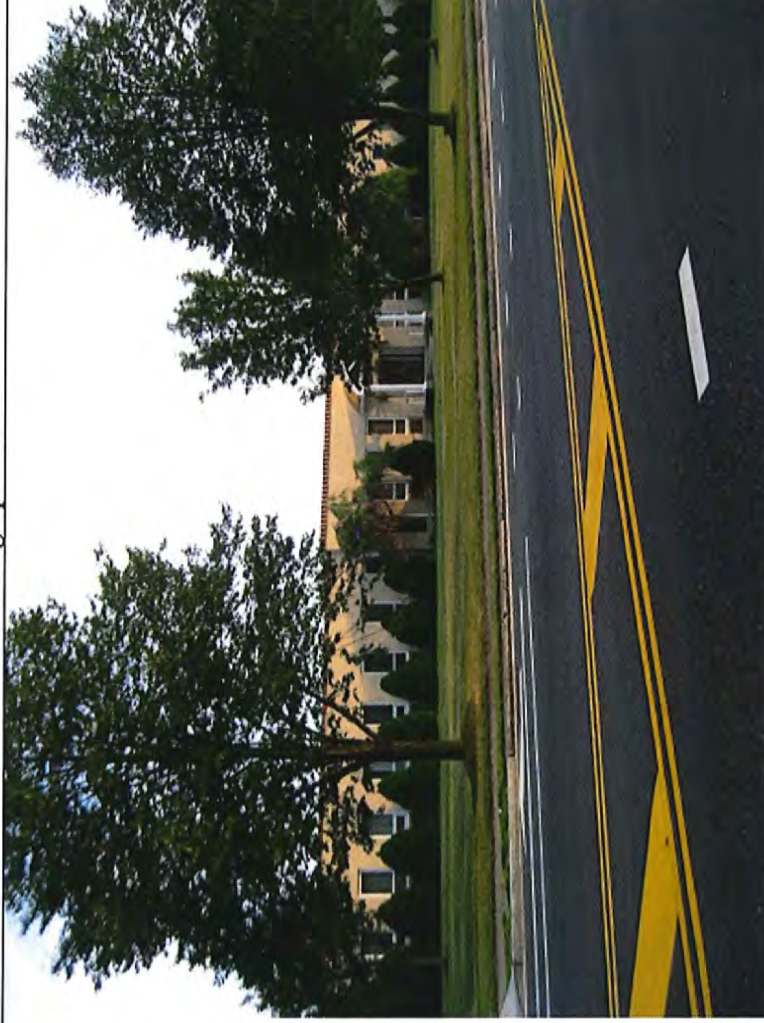
Photograph No. 64

SCTM No.:	Owner:	Land Use:	Zoning:	Lot Size (acres):	Comments:
800-2-28.1	Lock & McDowell, Inc.	Commercial	J4	1.90±	Commercial building observed to be in good condition.

View of property from Union Avenue
